Intel[®] Pentium[®] III Xeon[™] Processor Specification Update

Release Date: May 2002

Order Number: 244460-035

The Pentium[®] III Xeon[™] processor may contain design defects or errors known as errata that may cause the product to deviate from published specifications. Current characterized errata are documented in this Specification Update.

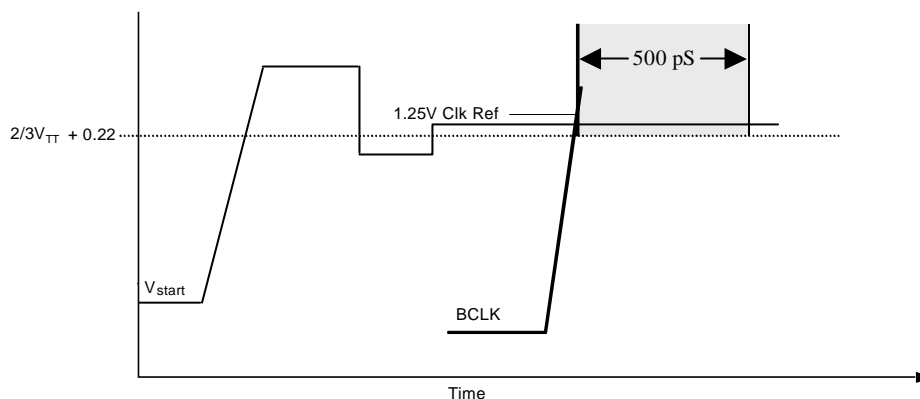
The published AGTL+ AC specification for $V_{IH(MIN)}$ is $(2/3 \cdot V_{TT}) + 0.1$ Volts.

Intel has characterized the new AGTL+ AC specification for $V_{IH(MIN)}$ on the processor's RS0# signal to be: $(2/3 \cdot V_{TT}) + 0.22$ Volts within 500 picoseconds following the rising edge of BCLK crossing the 1.25-Volt threshold. See below.

Implication: The deviation from the published specification results in decreased noise margin on the RS0# processor input. This decreased noise margin has been observed to be particularly detrimental in system environments where the RS0# processor input is being driven by an I/O buffer with a pull-up device (such as a p-channel transistor) that is switched off mid-cycle. Systems that employ I/O buffers that keep the pull-up device on for the entire cycle are significantly less affected by this erratum. The reduction in noise margin may lead to the generation of BINIT# (when enabled) resulting in a system reset, otherwise this condition may lead to a system "hang" condition.

Workaround: If a system design cannot meet the specification deviation, the following areas should be carefully examined to assure that additional margin exists in order to compensate for any deficit observed with respect to the newly characterized $V_{IH(MIN)}$ specification:

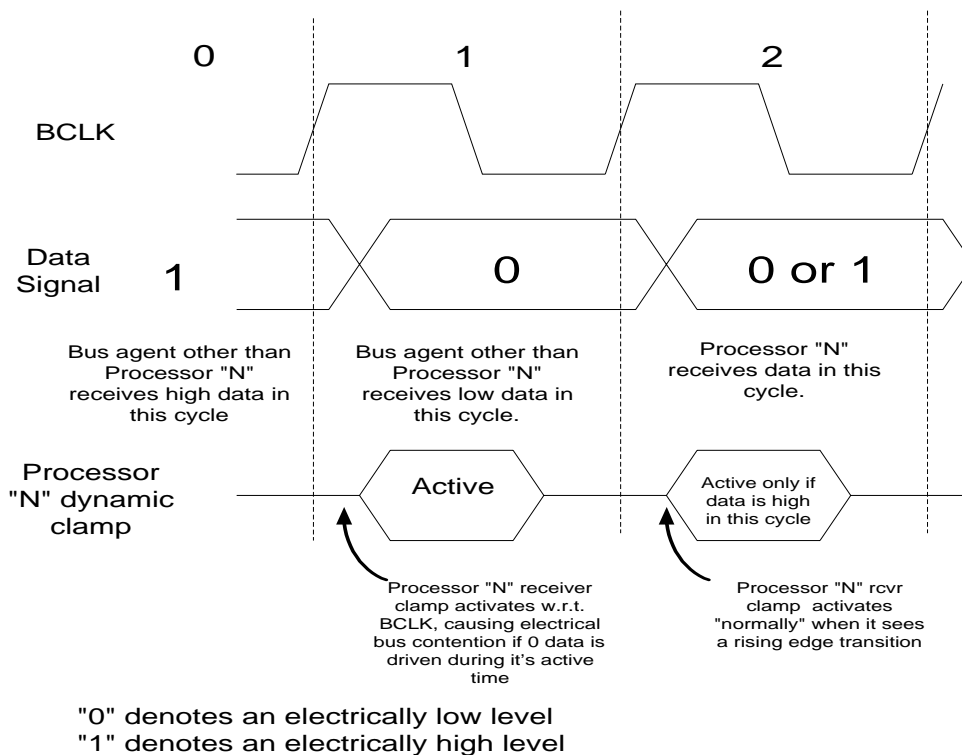
Problem: Falling edge ledge push-out and undershoot may be seen on AGTL+ data and data bus ECC signals. The AGTL+ receiver's dynamic clamp circuit activates (i.e. clamps the signal to an electrically high level) in certain cycles when data is driven to an electrically low level by another agent.

Implication: This erratum only occurs on a processor that does not receive data in that particular cycle. More specifically, this erratum only occurs when a specific processor does not receive data in the current BCLK period, but receives data in the very next period. Therefore, the processor inducing this falling edge noise (on data and data bus ECC signals) will not actually read the data in that cycle. See below for an illustration of this erratum affecting a processor denoted Processor "N". The falling edge ledges and undershoots may affect the signal quality and/or timing at agents that receive data in that cycle. Therefore, the impact of this erratum is highly dependent on system bus design.

Workaround: Evaluate system bus signal quality and timing margin at the valid receiving agent as a result of this falling edge noise. Due to dependence upon system bus design, bus layout may be evaluated to determine the need for improvements in signal quality and timing margin at the valid receiving agent as a result of this receiver-induced falling edge noise.
